TECHNICAL REPORT H-76-17

SLUICE PRESSURES, GATE VIBRATIONS AND STILLING BASIN WALL PRESSURES LIBBY DAM, KOOTENAI RIVER, MONTANA

October 1976 Final Report

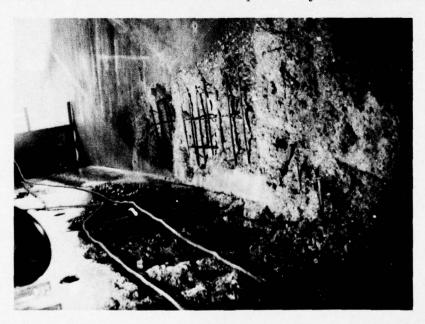
- 4. The center sluice, located in structure monolith 29, was severely damaged after a short period of operation, apparently by cavitation. An indication of the extent of the damage is given in Figure 4; note that the damage included deep erosion of the wall as well as the floor. The problem was reported to the U. S. Army Engineer Waterways Experiment Station (WES) in September 1973. The U. S. Army Engineer District, Seattle, proposed that WES place nine pressure transducers in the sluice floor, six of which would be in the reconstructed surface of the damaged area. These transducers would be used to monitor the pressure fluctuation amplitudes and frequencies. This information would be used to determine if negative pressures existed. These measurements were to be made for 1-ft increments of gate openings and closings. The range of openings would be from 1 ft to fully open (17.0 ft).

Figure 4. Erosion damage, center sluice, looking downstream

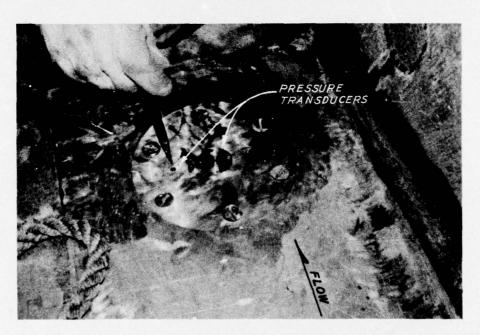
Figure 5. Installed cover plate and pressure transducers in sluice floor
